**Blackmiddens, Cabrach, AB54 4HP
Data Structure Report (DSR)**

**Alison Cameron
Cameron Archaeology
Date: 24 April 2019**

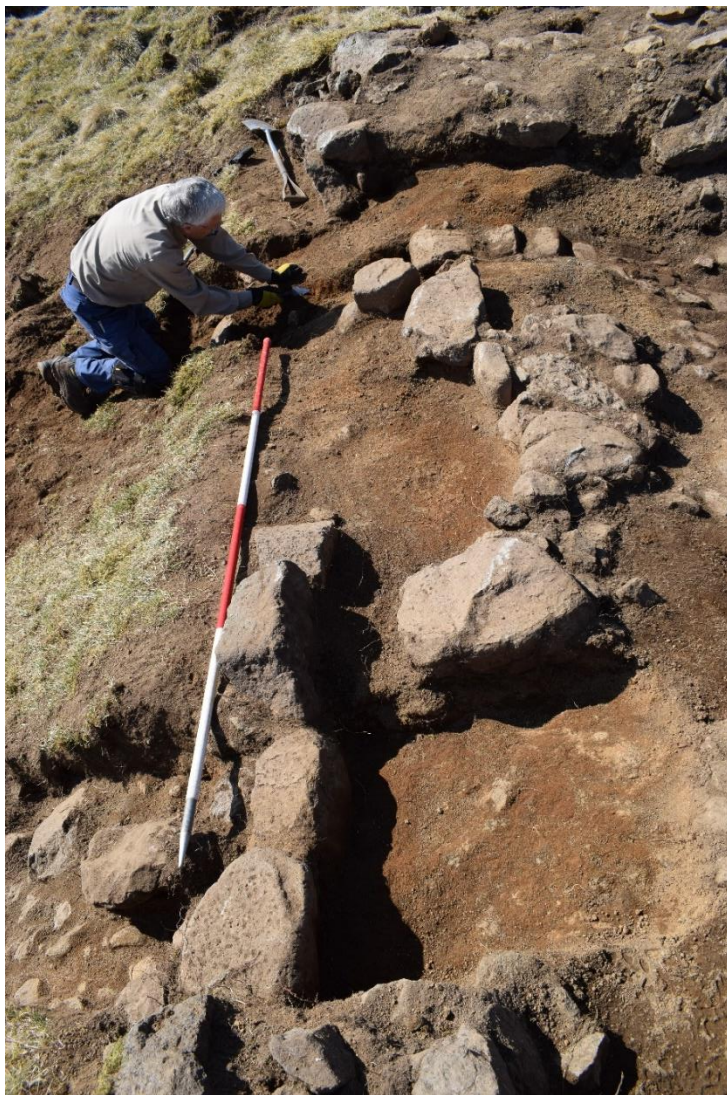
Illus 6 Room 1 S edge with stone alignment 48 (bottom) and circular stone alignment 50 (centre); facing W

There is a line of stones 48 at the S of the room (Illus 6); this is not substantial enough for a wall foundation as seen on the other walls of the building. This is therefore being interpreted as a base of a wooden partition or a low wall. This may have been an open access area, however, and the area between the S edge of cobbles 21 and these stones was filled with compact natural gravel and this may be a repair to the floor of this room and would have allowed for barrels to be rolled from the centre of the room to the S edge of the building. There is also a semi-circular setting of large and small stones (50; Illus 6) in the centre of the S edge of the building and this has compact gravel natural subsoil in the centre and was probably a base for a tank or barrel.

There is a steep slope to the S of the building; there is stone (46 and 47) which is either a revetment or may be the remains of demolition material fallen down the slope (Illus 6).

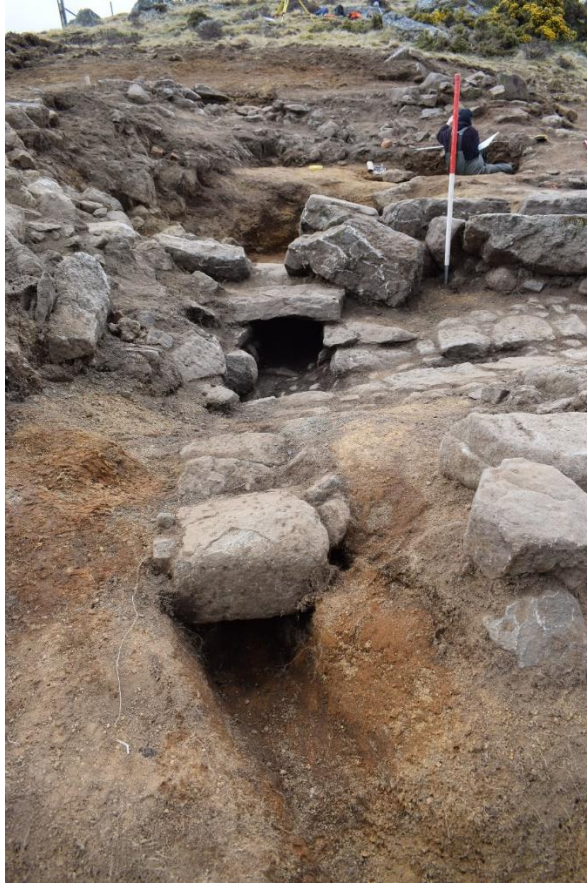
Illus 7 Drain 29 (foreground) and drain 51 (centre) through partition wall 26; facing N

Cut through the natural subsoil at the S of the building is drain 29. The S end is cut into the compact natural gravels and most of the feature is capped with flat stones. The drain goes under the floor of Room 1 and into Room 2 to the N. When partition wall was constructed a culvert (51) was created under this wall. The drain also heads W through wall foundation 17 but this area was unsafe to excavate at the current time.

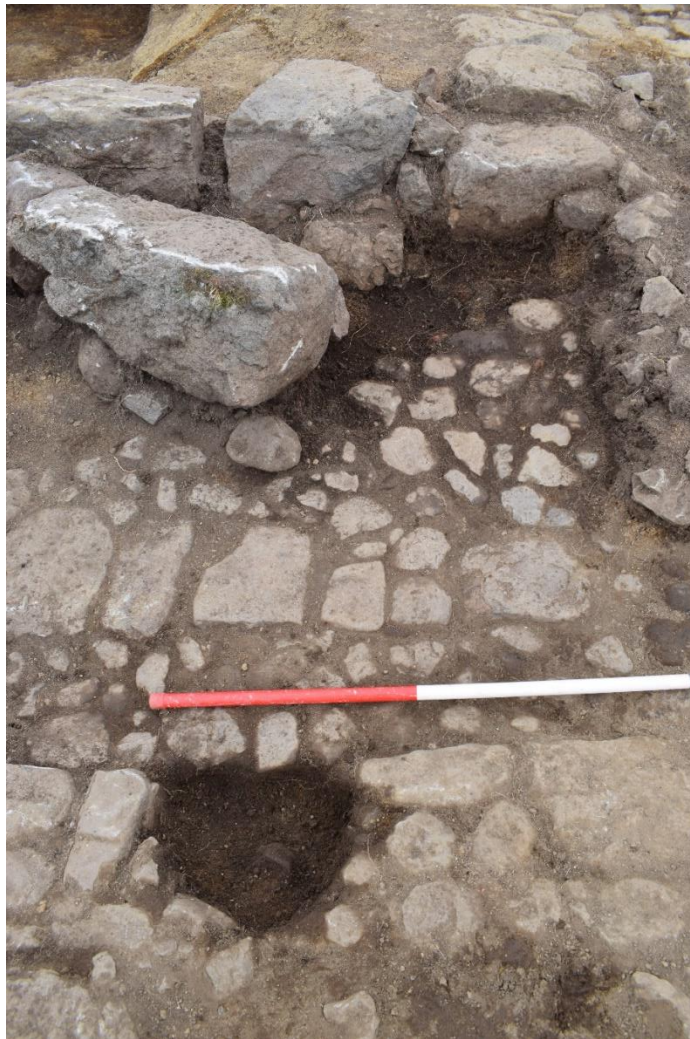
Illus 11 Void in cobbles 22 (44); runnel 20 (centre), cobbles 19 with partition wall 26 (top); facing N

A semi-circular section of cobbles 22 was removed (44; Illus 11) and this may have been used as a base for a post but it is not deep enough for a post-hole.

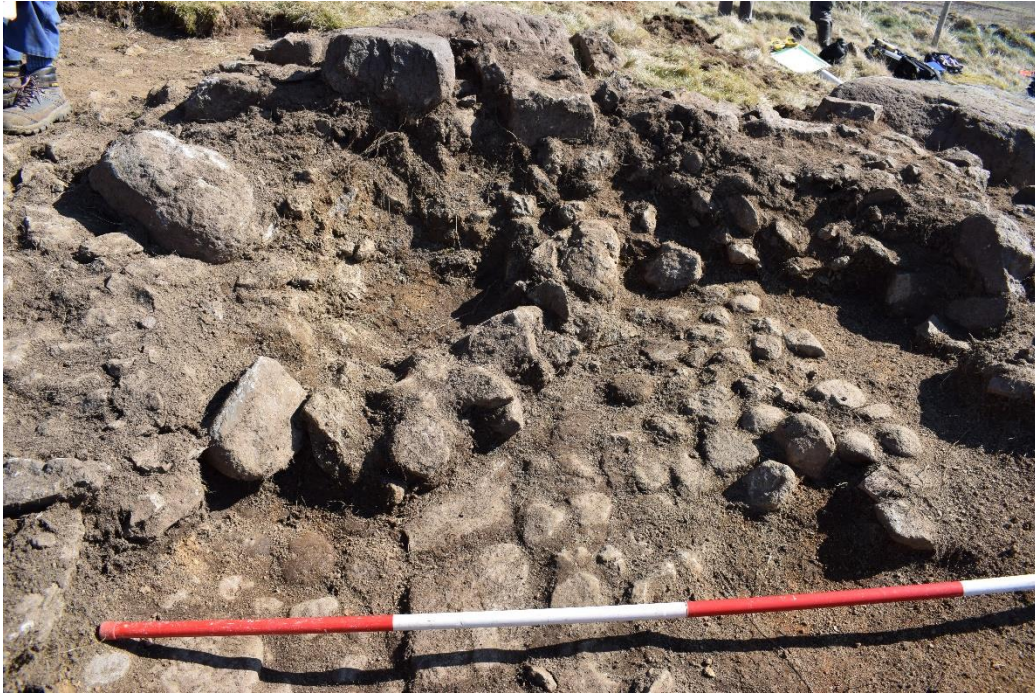
Illus 13 Phase 2 stone setting (25) with sloping cobbled surface 21 (right) and wall foundation 11 (top); facing E

On the E wall of Room 1 a layer of redeposited natural gravels was laid over cobbles 21 and then a semi-circle of stones and clay (25; Illus 13) were attached to the E wall. There was no burning so this is not a hearth and it may be a setting for a barrel or tank. It was insubstantially built.

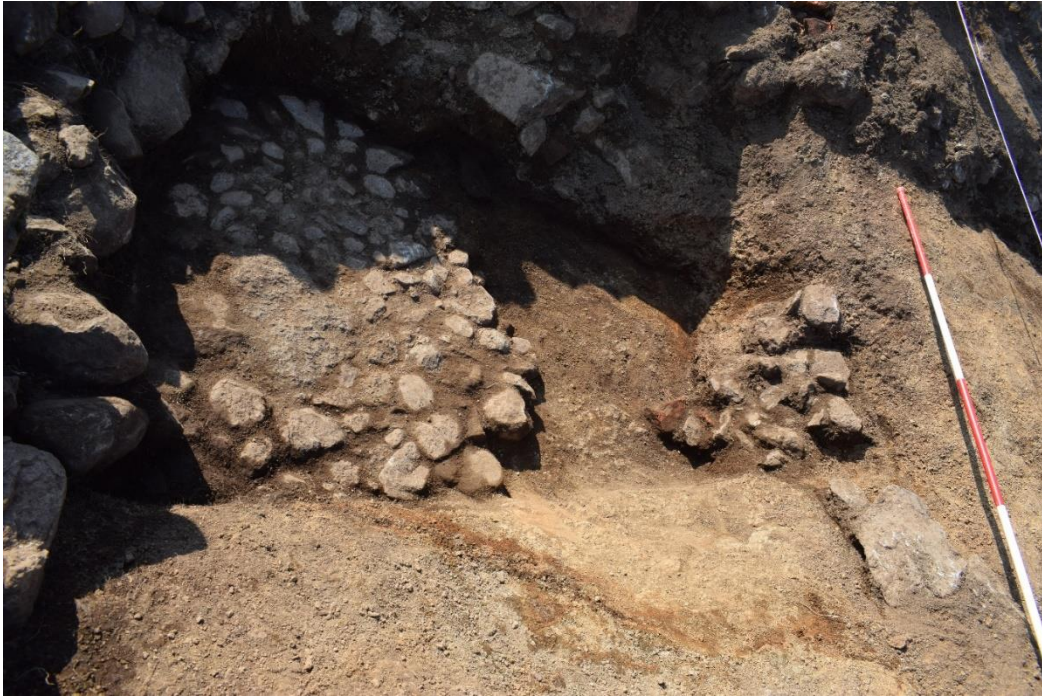
Illus 16 Room 2 cobbled surface 32 (left) and stone, brick and soil rubble 40 (right); facing W

The room was constructed by cutting down into the natural gravel on the N and E sides creating a steep slop on each face. Medium rounded cobbles (32; Illus 16) were laid on the S end of the room with larger flat stones placed at the junction of this room with the phase 2 partition wall 26. Soil, brick and stone had been dumped in the N edge of this room (40; Illus 16) and soil and brick trampled onto the N end of the room. When this was removed natural compact gravel was located underneath. Latterly the room had clay pipes and glass bottles smashed on the floor (Illus 17); the glass has been dated to the 1860/70s at the earliest, 1880s/90s at the latest (Colin MacKenzie, Cabrach Trust trustee pers comm) and this activity post-dates the distillery. It is likely that this room was still open and may have formed a refuge for farm staff to drink and smoke before the room was backfilled to ground level with large stone and brick demolition rubble.

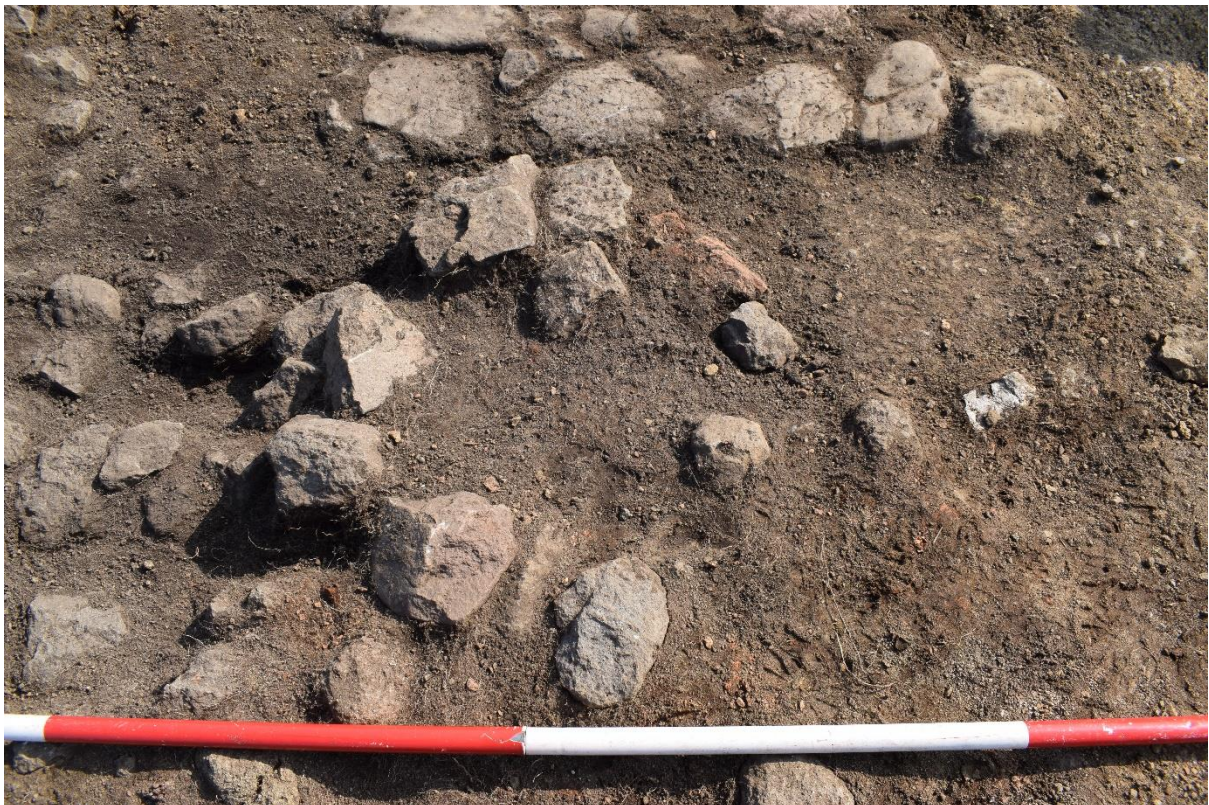
Illus 19 Circular stone setting 56; facing N

There are also a number of stone settings including circular area 56 (Illus 19) and semi-circular setting 24 as well as linear stone spread 39 which continues to the exterior of the building. The former areas may have been settings for tanks or barrels and the stone
