# Impacts of Climate Change on Coastal Archaeological Sites in County Kerry, Ireland

*Fergus McCormick and Melissa Nicolas*

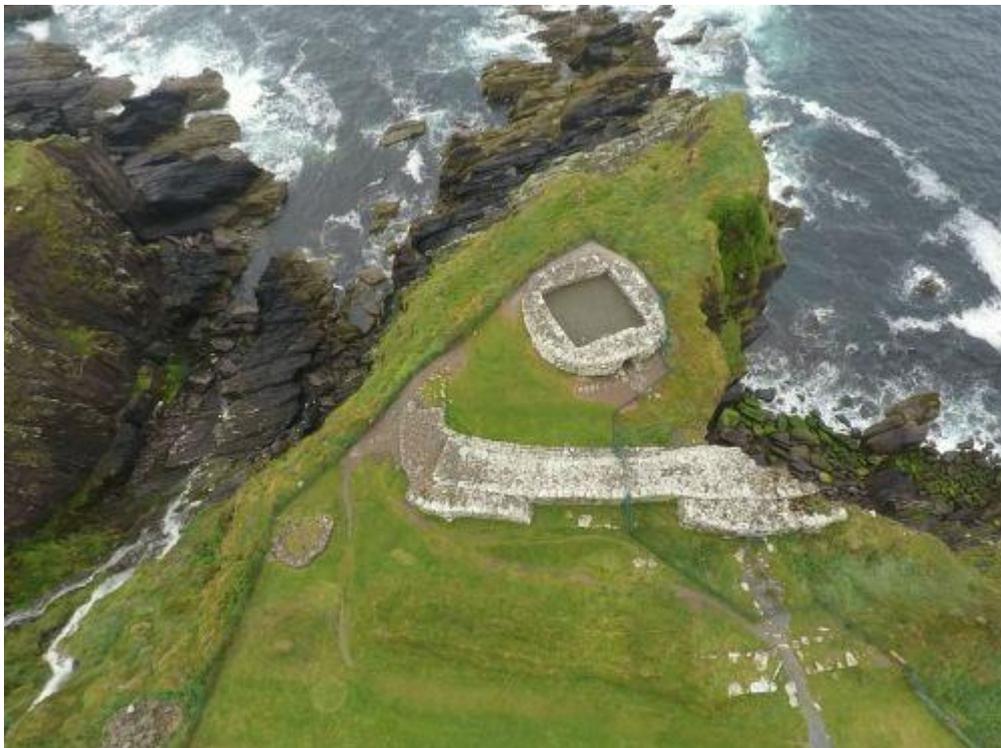
Figure 1: Aerial view of Dunbeg Fort (Image credit: OPW)

Dunbeg Promontory Fort is located on a sheer cliff overlooking the Dingle Peninsula in County Kerry, Ireland (Figure 1; Cuppage [1986](#)). It is a National Monument site in state guardianship and is one of the Wild Atlantic Way coastal touring sites. The access path to the site is privately owned by a local family. The fort contains four outer defensive banks of stone and earth. Inside the fort are the remains of a drystone Clochán (beehive hut) and a souterrain (Harbison [1992](#)). There is difficulty in determining a precise date for the site owing to the absence of dateable finds and records. A radiocarbon date from the inner fosse suggests that it dated back to the 8th or 9th centuries AD. Another radiocarbon date of the layers in the Clochán suggests that it was inhabited in the 10th or 11th centuries AD.

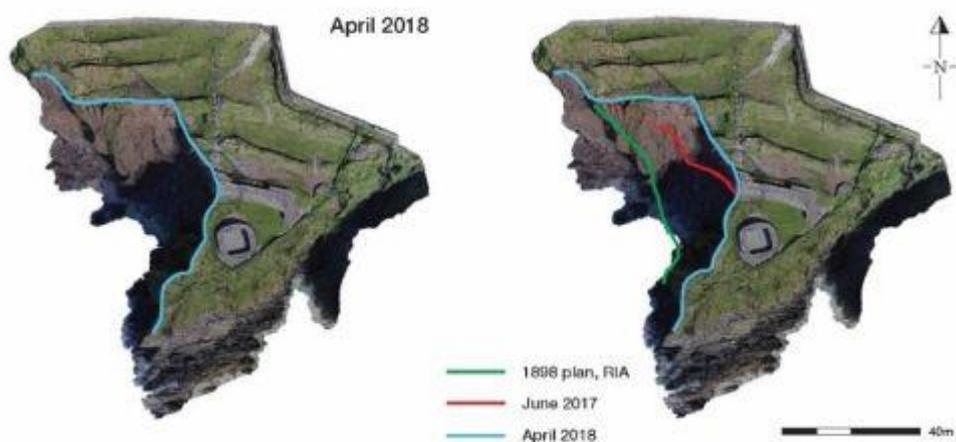
Figure 2: Coastal erosion at Dunbeg Fort (Image credit: The Discovery Programme)

The location of Dunbeg Fort is making it vulnerable to natural weather events and is threatening the site's existence (Figure 2, Figure 3). The fort suffered from extensive coastal erosion in the early 19th century, and in 1977 the Office of Public Works (OPW) carried out an archaeological excavation to record the site and its history before any further damage could occur. The excavations were carried out by archaeologist Terry Barry. Further locations have been excavated in 2018 by consultant archaeologist Laurence Dunne.

A considerable part of the cliff collapsed into the sea in recent years owing to the increased frequency and severity of storms and precipitation. This has led to significant loss of the historic fabric and archaeological elements. The site is particularly vulnerable during the winter season between December and February because of its exposed location. A storm in January 2014 caused a portion of the cliff to collapse into the sea. Between 2017 and 2018, severe weather caused further damage and a significant part of the historic fabric, including the entranceway, was lost into the sea (Figure 4). The dramatic collapse sparked national attention and was covered in the national news (RTÉ [2018](#)).

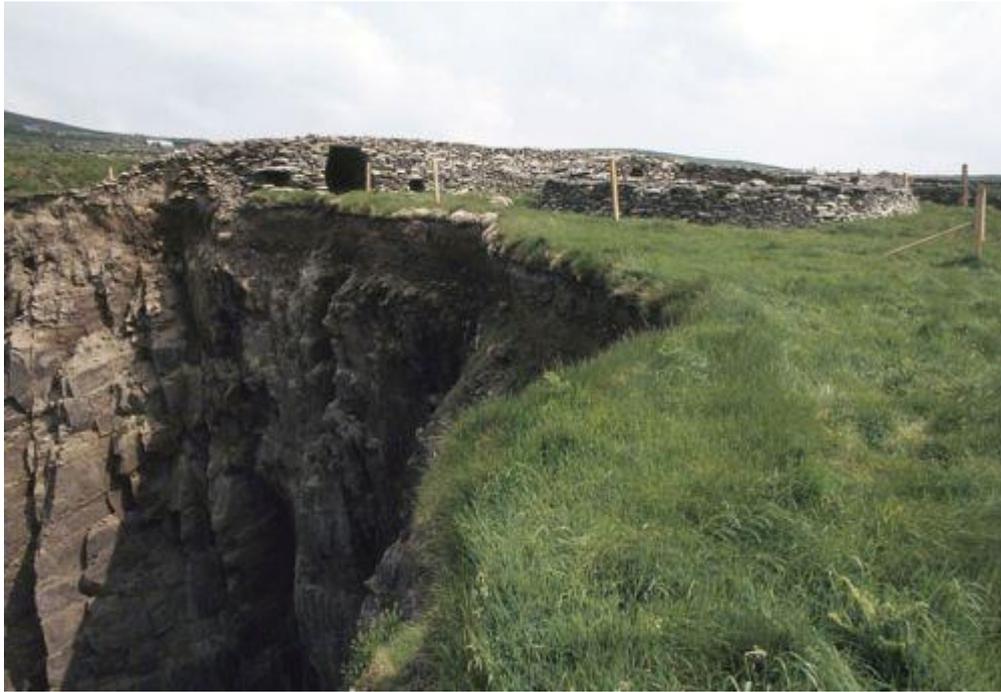
Figure 3: Earlier image of Dunbeg Fort coastal erosion (Image credit: DHLGH)

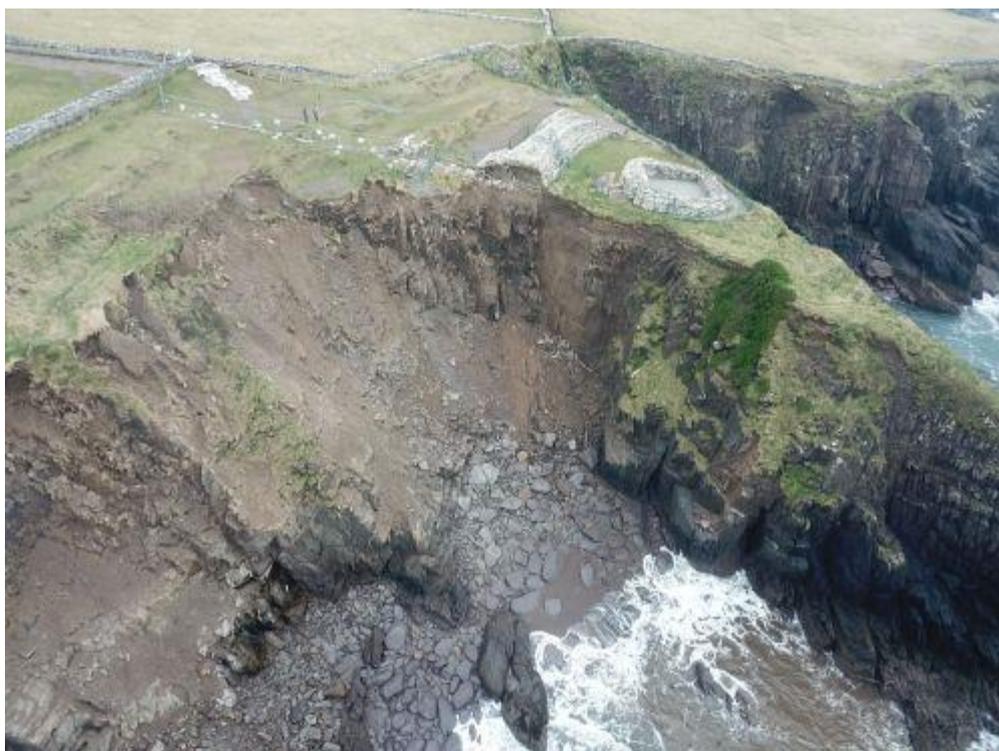
Figure 4: Aerial image showing the coastal erosion in 2018 (Image credit: OPW)

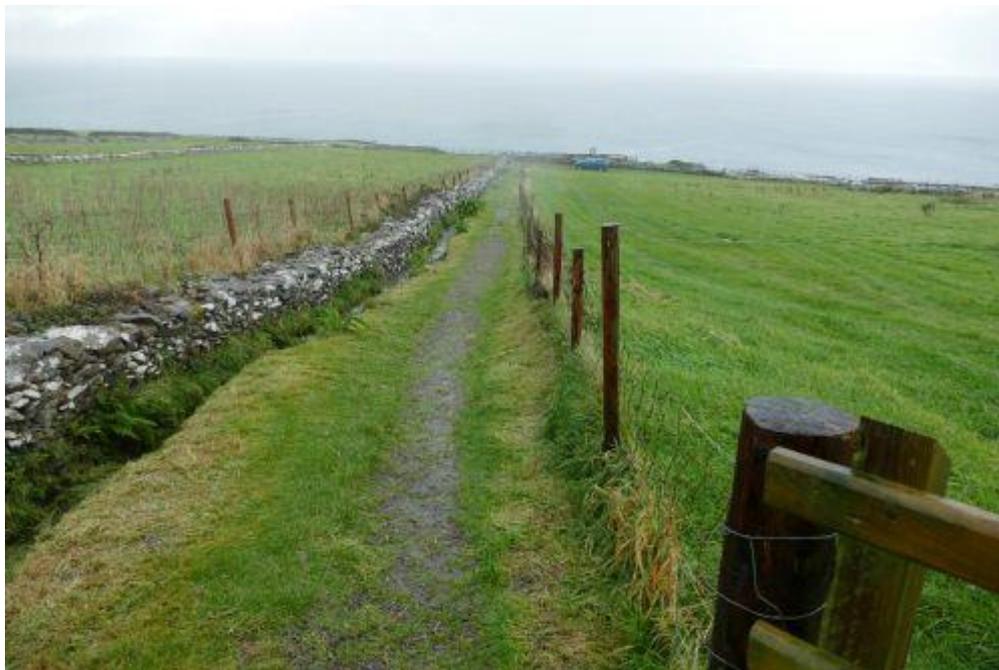
Figure 5: Pathway connecting the main road to the National Monument site (Image credit: OPW)

The OPW has also applied for a Ministerial Consent from DHLGH in 2022 to install fencing and repair the existing pathway connecting the main road to the National Monument site (Figures 5-9). The Ministerial Consent will be accompanied by an archaeological method statement report. It is proposed to carry out the repair works to the pathway and the fence installation in 2022.

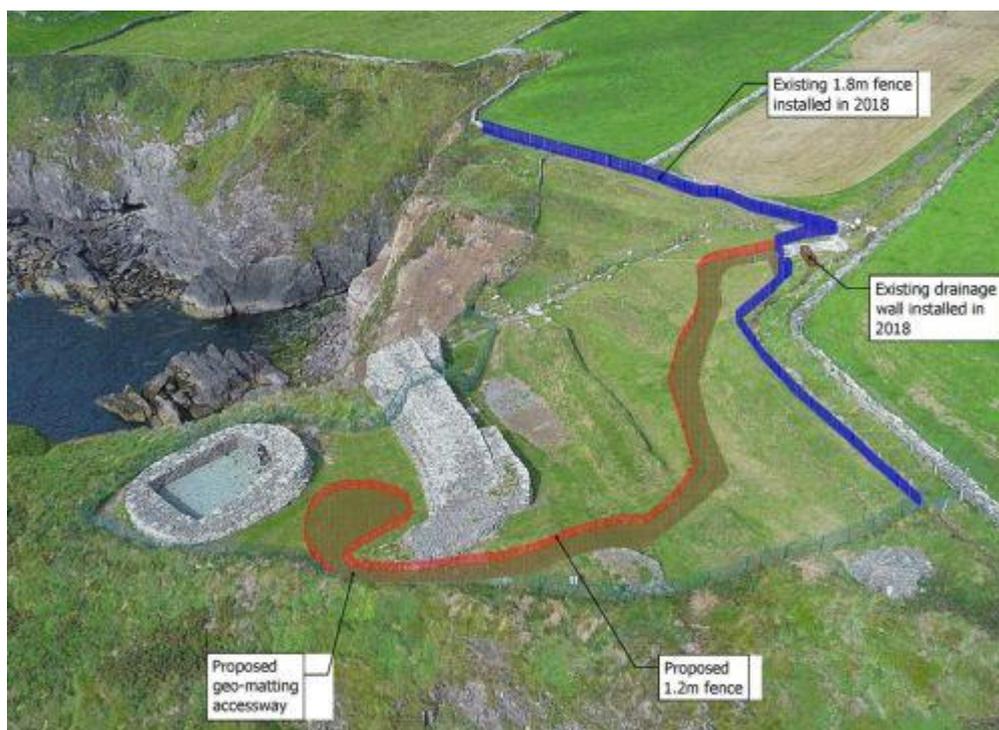
Figure 6: Drawing of proposed fencing, subsequently installed in 2019 (Image credit: OPW)

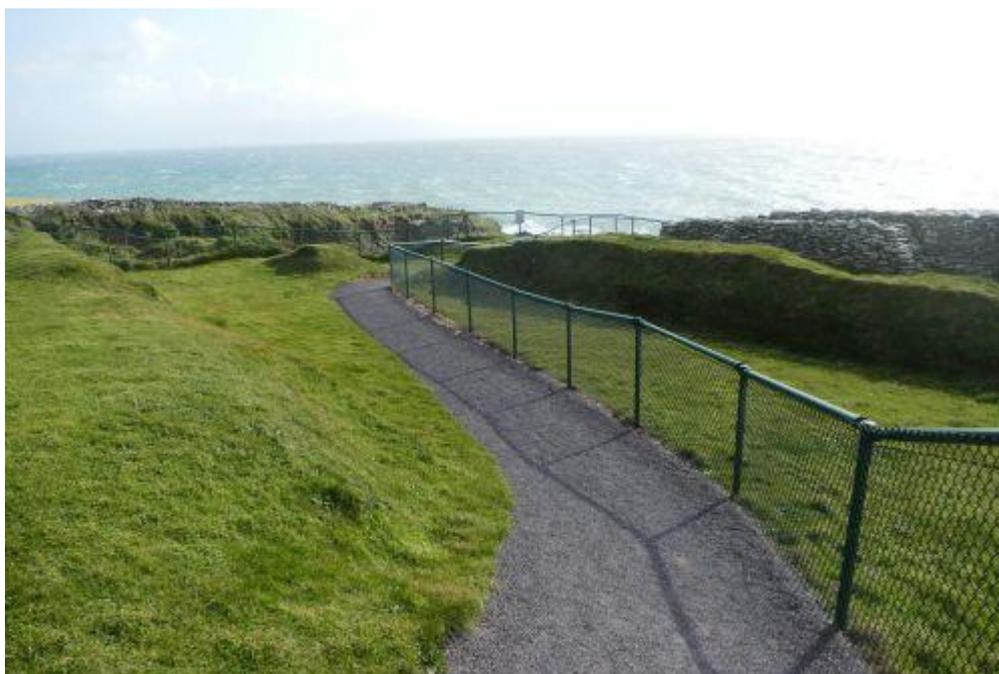
Figure 7: New safety fencing installed in 2019 by OPW to allow safe access to the site for visitors (Image credit: OPW)

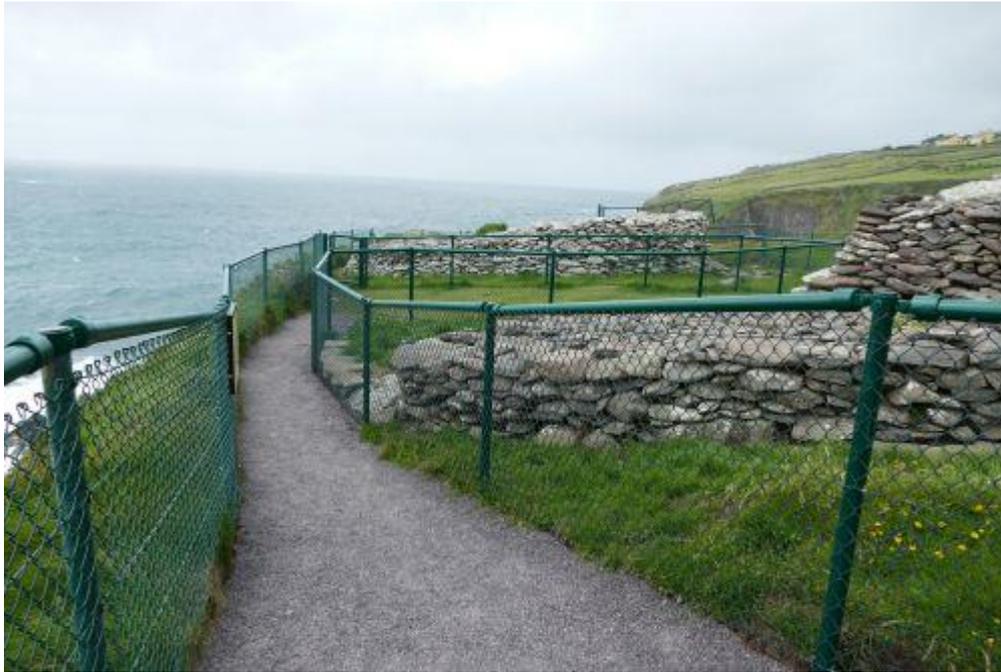
Figure 8: New safety fencing installed in 2019 by OPW to allow safe access to the site for visitors (Image credit: OPW)

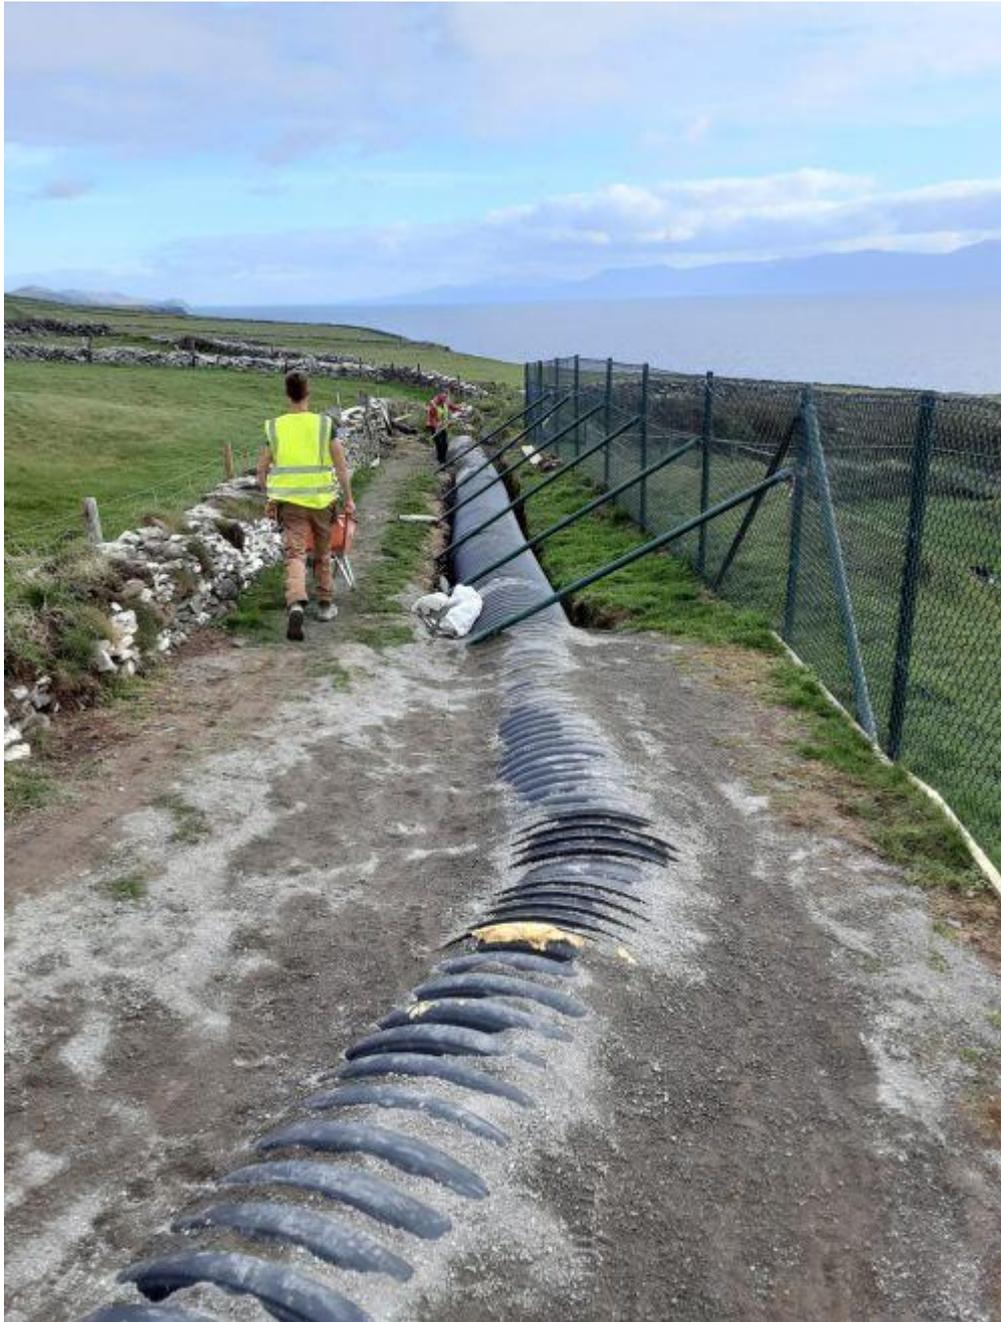
Figure 9: New culvert drainage pipework (Image credit: OPW)

The OPW applied for a second Ministerial Consent in 2018/2019 to install fencing to limit visitors' access to specific areas that are considered safe. The existing drainage system has also been repaired and a new drainage wall has been constructed to redirect floodwater from the site. Dunbeg Fort was reopened in 2019 to allow visitors to the site and so benefit the local tourist economy. However, the drainage repairs carried out in 2019 were insufficient to protect the site from flooding. As a result, the OPW have installed new culvert drainage pipework to mitigate the risk of flooding.

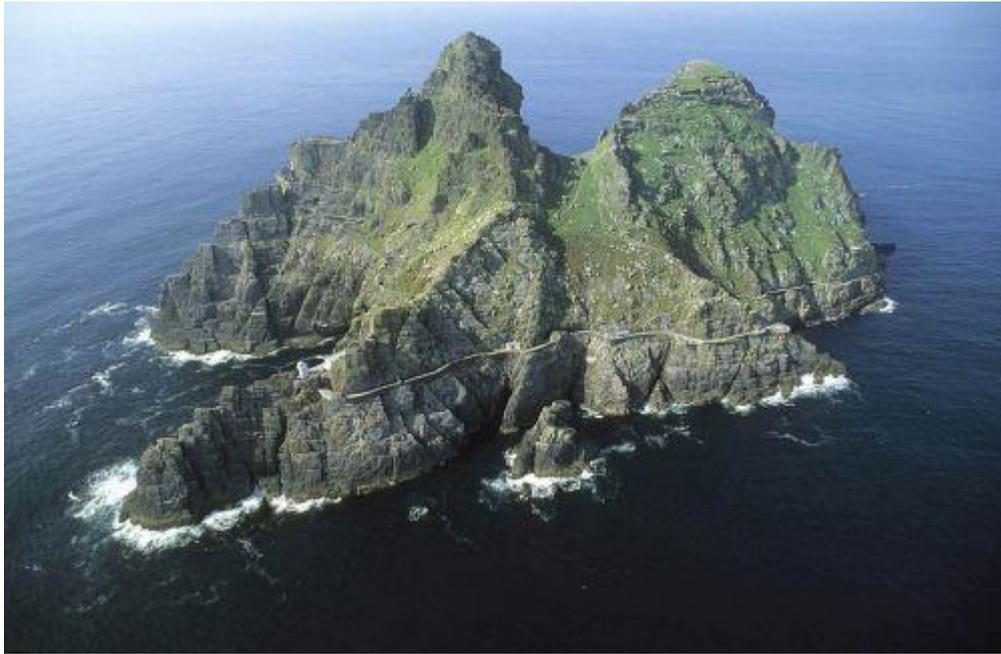
Figure 10: Aerial view of Skellig Michael (Image credit: DHLGH)

Skellig Michael (UNESCO [2020](#)) is an island located 13km off the South Kerry Coast and is home to an early medieval monastic site (Figure 10; KE104 in the [Historic Environment Viewer](#)). It was founded c. 6th century by Saint Fionán. The medieval monastery is dramatically situated on the top of this rocky island in the Atlantic Ocean (Figure 11, Figure 12). As a result of climate change and increasingly rough seas, the monks later transferred to the mainland at [Ballinskelligs Priory](#) (Harbison [1992](#)).

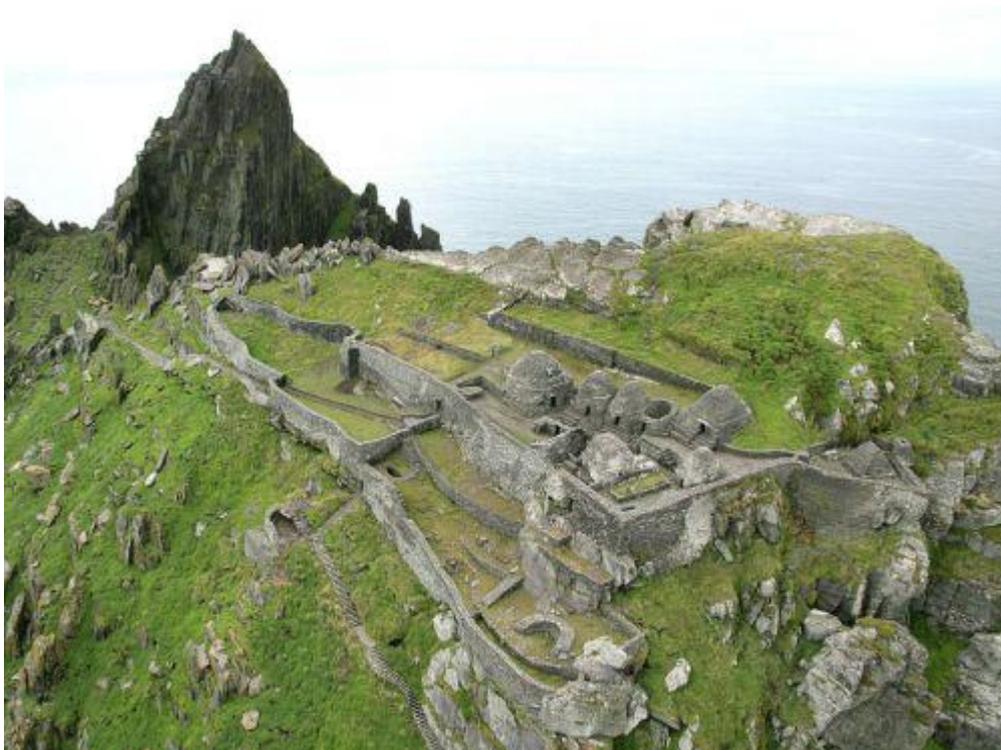
Figure 11: Aerial view of the monastery at Skellig Michael (Image credit: DHLGH)

There are two major international sites of interest on the island. The monastery enclosure located on the eastern side of the island contains a series of terraces, dry stone enclosing walls, three cisterns, seven corbelled cells (six intact) and two oratories. There are also the remains of St Michael's chapel. The monastic settlement was accessed via a series of three stairways, only one of which is accessible today. The South Peak contains the remains of a hermitage, constructed ledges and altar remains. The other features include a pier, a helipad and two lighthouses built in the 1820s and a lighthouse road.

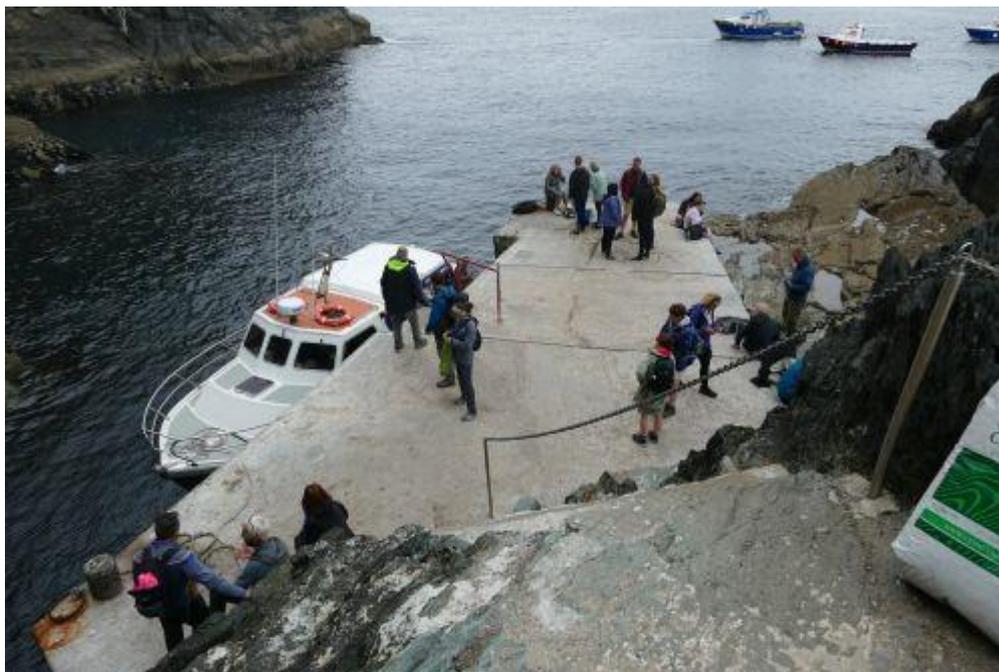
Figure 13: Tourists arriving at the landing pier (Image credit: OPW)

Skellig Michael is accessed by boats departing from Portmagee or Knight's Town on Valentia Island. Boats land at the pier and passengers disembark by climbing the steps (Figure 13). The visitors then ascend the Lower Lighthouse Road to reach the base of the eastern steps, where an OPW guide gives an induction before directing them to the monastery steps. Additional guides are located at the monastery complex, completing the tour.

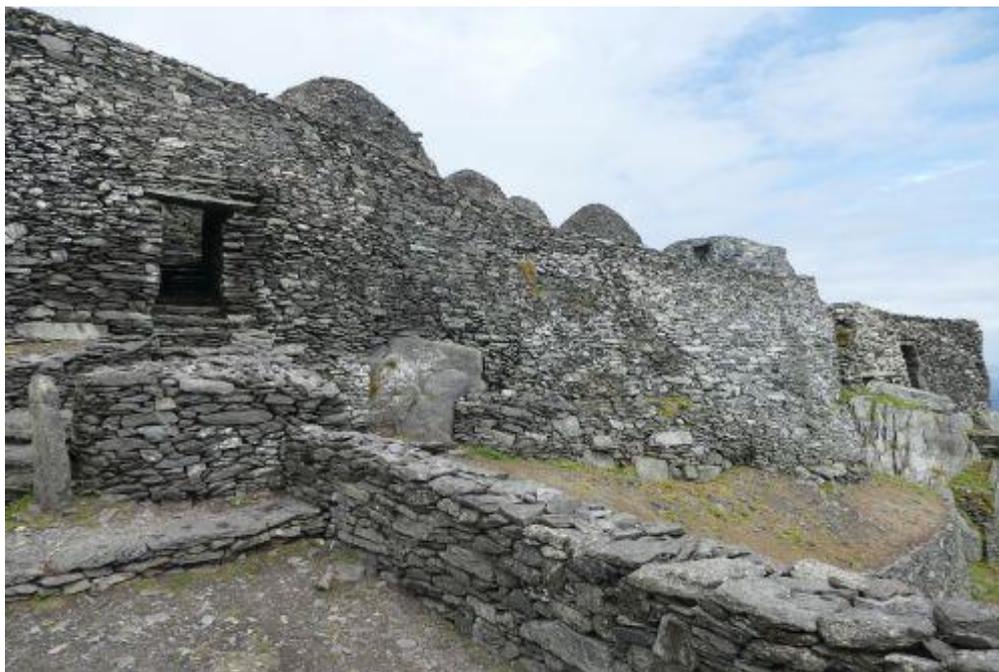
Figure 14: Monastery retaining wall in danger of collapse (Image credit: OPW)

Climate change continues to be a threat to Skellig Michael and the OPW are continuously looking for ways to mitigate its associated risks. One section of the monastery retaining wall at Skellig Michael has become structurally unstable owing to the increase in rainfall and rainwater draining through it.

The OPW has commissioned The Discovery Programme to monitor the movement of the wall on a yearly basis. [The Discovery Programme](#) undertake a survey of the monastic settlement every year and publish their findings to the OPW. The latest 2021 report confirmed that the section of the retaining wall directly below St Michael's chapel is currently undergoing minor movement beyond acceptable tolerances, but at a slightly reduced rate than that observed in 2020. This section of the monastic wall has been historically susceptible to collapse, with major reconstruction having been undertaken during the 19th century. The OPW is proposing the careful dismantling and rebuilding of the wall to address the rainwater drainage issue. The monastery wall will have to be carefully reconstructed without compromising the site's authenticity and Outstanding Universal Value (OUV).

The OPW appointed Paul Corrigan Associates (PCA) surveyors in 2022 to carry out a digital survey of the monastery and retaining wall (Figure 14). The survey works were completed in the 2022 season and the survey drawings were issued to the OPW. The survey drawings will allow the OPW to determine the conservation methods to be adopted in proposed future conservation works. These will also form the basis for Ministerial consent applications, design decisions and tender packages.

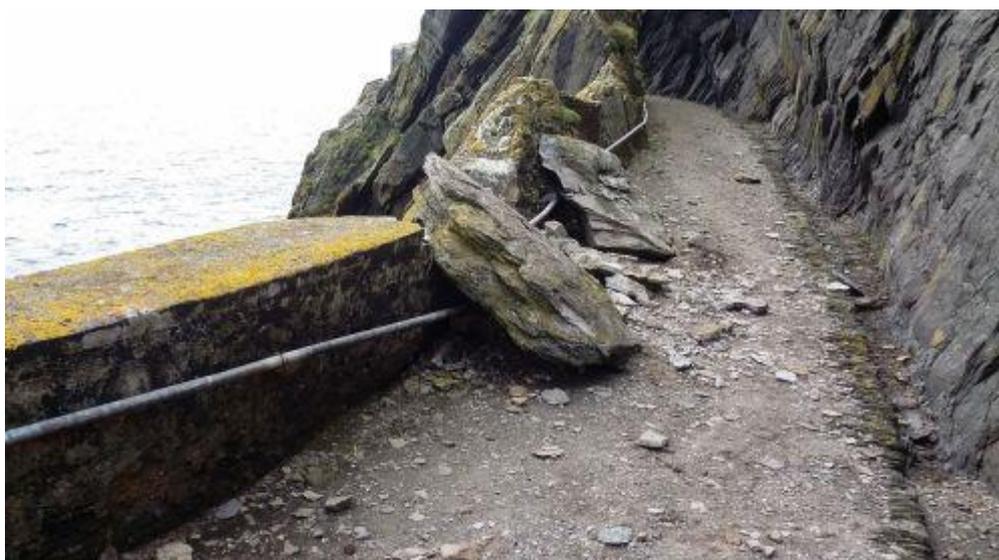
Figure 15: Rock fall in 2017 (Image credit: OPW)

In recent years, increased rainfall has also resulted in increased rock fall that is damaging the fabric of the site and threatening the safety of both OPW staff and visitors to the island. In 2017, a rock fall occurred near the guides' accommodation, causing a major safety risk for staff (Figure 15). The increased rock fall at the time caused damage to the lighthouse road, an important architectural feature. The erosion is also the result of natural causes such as wildlife burrowing on site. Another serious rock fall occurred in July 2020 near the OPW workers' huts (Figure 16). This has highlighted the urgency of installing new permanent crash decks to protect OPW workers in area at high risk from rock fall events.

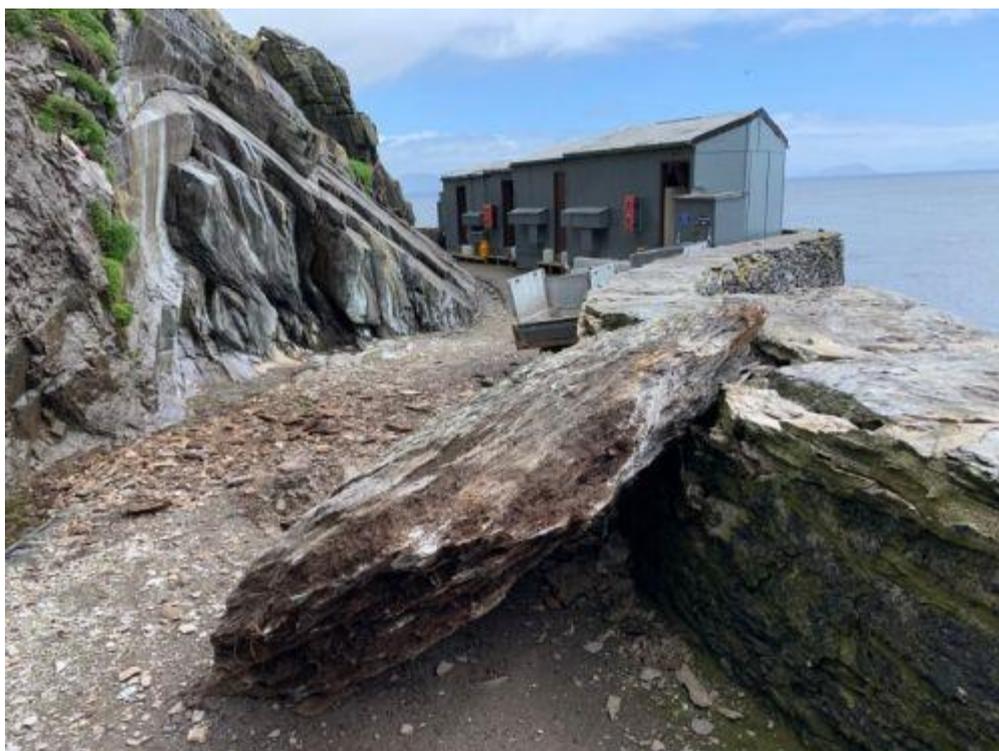
Figure 16: Rock fall in 2020 (Image credit: OPW)

Rock fall is a high-risk threat to the safety of OPW staff and visitors. Both rock fall and increased rainwater are damaging the unique historic fabric of the site. The substantial rock fall that occurred in 2020 resulted in the installation of temporary crash decks in locations with high incidence of rock falls (Figure 18, Figure 19).

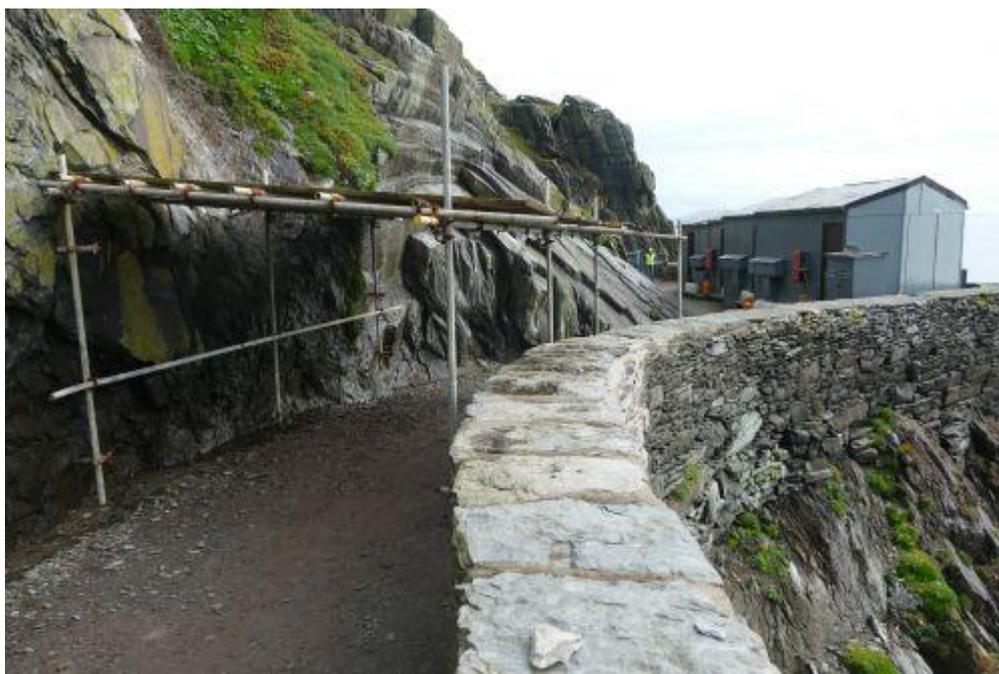
Figure 18: Temporary crash deck installed in the location of rock falls (Image credit: OPW)

In response to the threat to the health and safety of the workers, the OPW appointed Downes Associates as consultant structural engineers in 2021 for the design of three permanent crash decks in the critical locations on the Lighthouse Road. The OPW obtained DHLGH Ministerial Consent in August 2021 for the installation of permanent crash decks. The OPW also appointed a consultant quantity surveying firm, Rogerson Reddan, for the tendering process of appointing a contractor. The tender invitations were issued in 2021 but the process took longer than envisaged and there was not enough time to carry out the works. As a result, the OPW intend to re-issue tender invitations in 2022 and appoint a contractor for the installation of the crash decks.

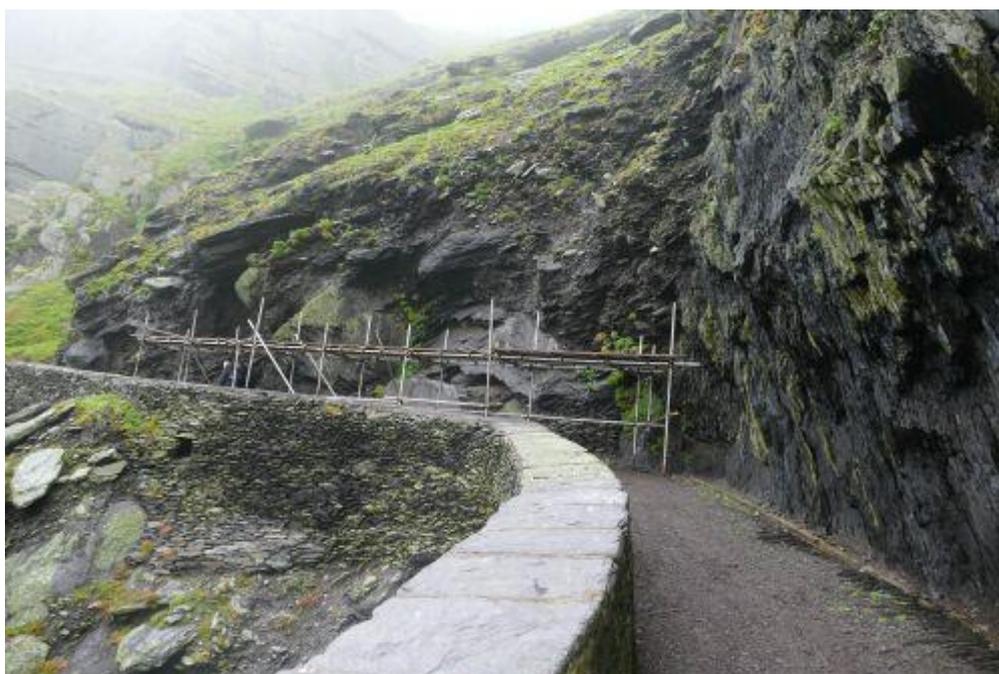
Figure 19: Temporary crash deck installed in a critical location on the Lighthouse Road (Image credit: OPW)

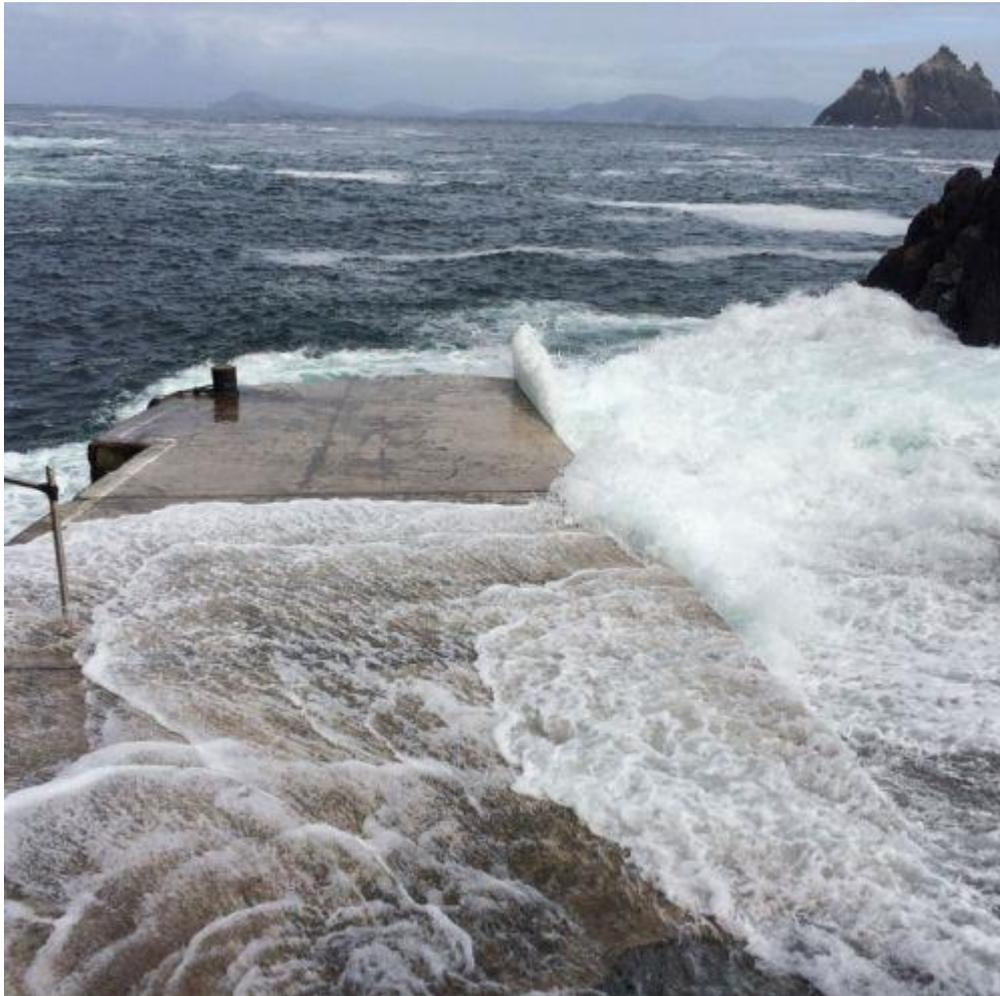
Figure 20: Landing pier during high sea swells (Image credit: OPW)

The increase in sea levels, sea swells and the increasing severity of storms have also been affecting access to the landing pier (Figure 20). The number of days when tourists can access the island during the summer tourist season has been steadily decreasing. The viability of the island as a tourist destination will be affected by climate change. The OPW are exploring long-term solutions to enhance the landing to the island and compensate for rising sea levels. A pier wall will be constructed to protect visitors from increased swells and higher tides. There is a more long-term strategy of increasing the height of the pier to accommodate predicted sea level rises

resulting from climate change. The OPW will keep maintaining and carrying out repairs to the existing pier as required to ensure safe landing onto the island.

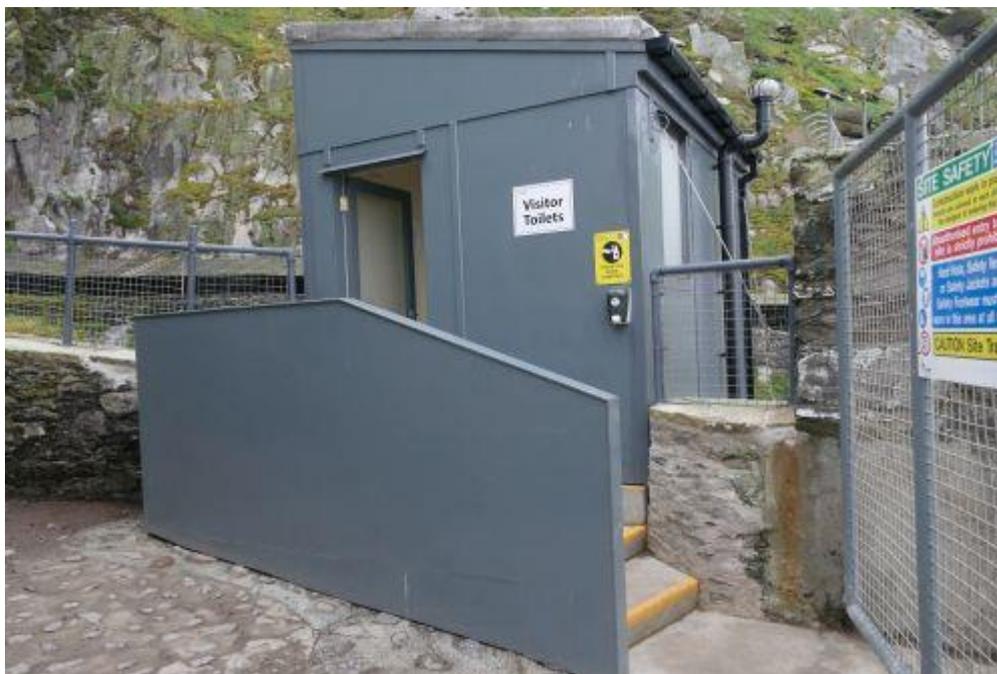
Figure 21: New visitors' toilets installed near the helipad in the 2021 season (Image credit: OPW)

The OPW also installed new visitors' dry toilets in the 2021 season near the helipad on the lighthouse road (Figure 21). The works were subject to Ministerial Consent which was granted by the DHLGH in May 2021. The visitor toilets opened to the public on 24 August 2021 and are the first public toilets to be constructed on the island. They consist of two dry toilets and hand sanitation stations. Improving toilets

and hygiene facilities on the island has become a necessity following the Covid-19 pandemic. The installation of such toilets is important for the viability of Skellig Michael as a World Heritage site and tourist destination.

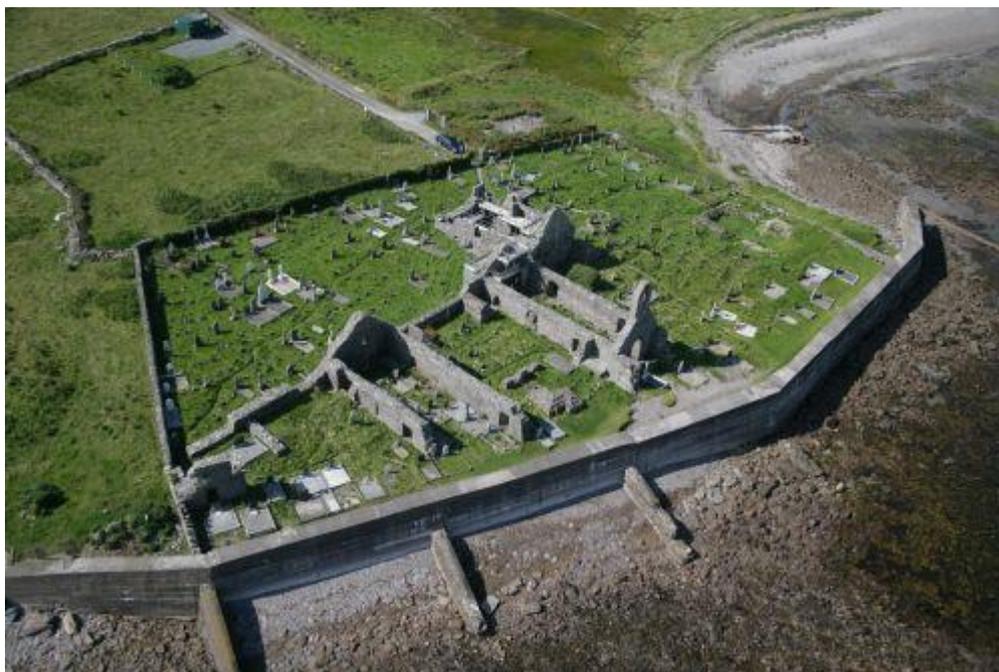
Figure 22: Aerial view of Ballinskelligs Priory and the existing concrete sea wall (Image credit: DHLGH)

A significant amount of this historic site has been lost to coastal erosion throughout the years. As a result, a concrete sea wall was built in the 1950s to prevent further loss of the historic fabric. The sea wall is now deteriorating and is in urgent need of upgrading and repair. The OPW has been carrying out conservation and repair works to the priory for the past 10 years. In recent years, the increasing storm surge and water penetration to the site and over the sea wall has caused damage to the ruined structures and threatened their survival (Figure 24, Figure 25).

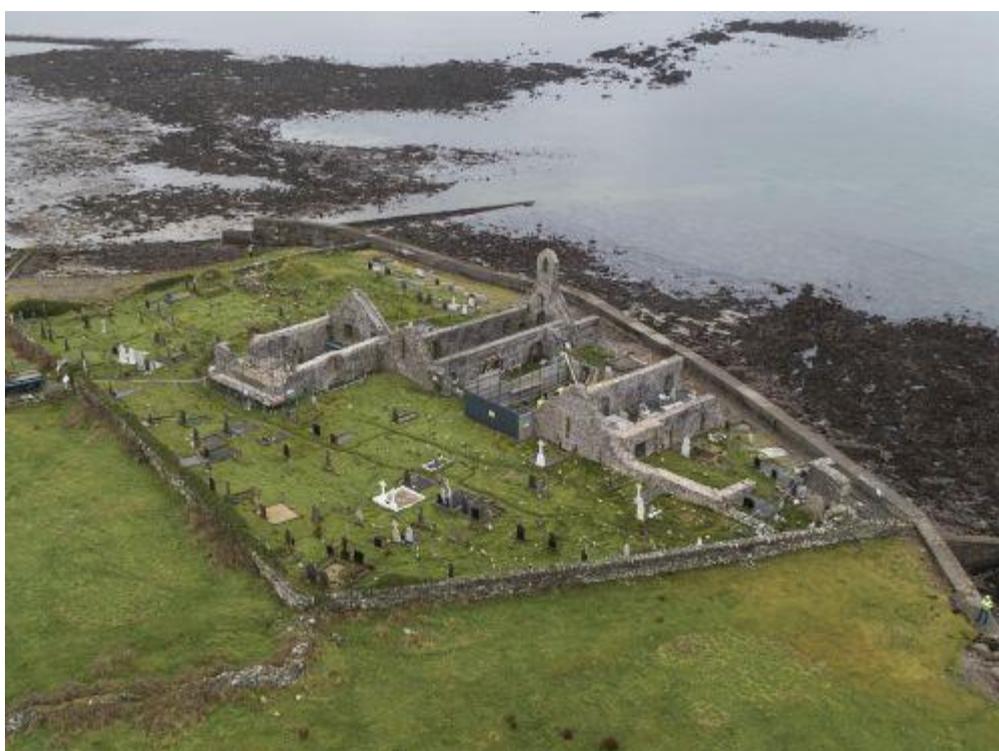
Figure 23: Aerial view of Ballinskelligs Priory (Image credit: DHLGH)

Ballinskelligs Priory is located on the west shore of [Ballinskelligs](#) bay in County Kerry (Figure 22, Figure 23). It was founded by the monks who came to the mainland from Skellig Michael between the 12th and 13th centuries. The remaining structures on site date back to the 15th century. They include two churches that have windows and doors with dressed stones, and a cloister garth with a large hall (Harbison [1992](#)). Ballinskelligs Priory is one of the significant spiritual sites dedicated to St Michael in the area. It is a destination for visitors searching for spirituality and history. Its location on the Wild Atlantic Way also makes it a main tourist destination. The site contains a large graveyard that is still in use by the local community.

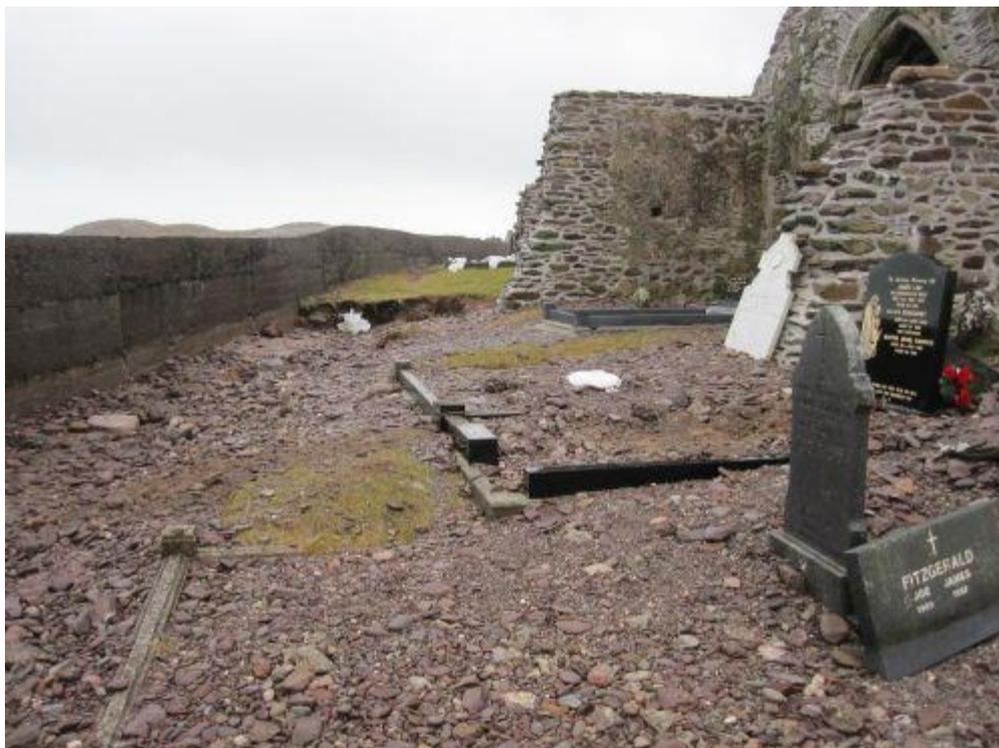
Figure 24: Storm damage in 2014 (Image credit: OPW)

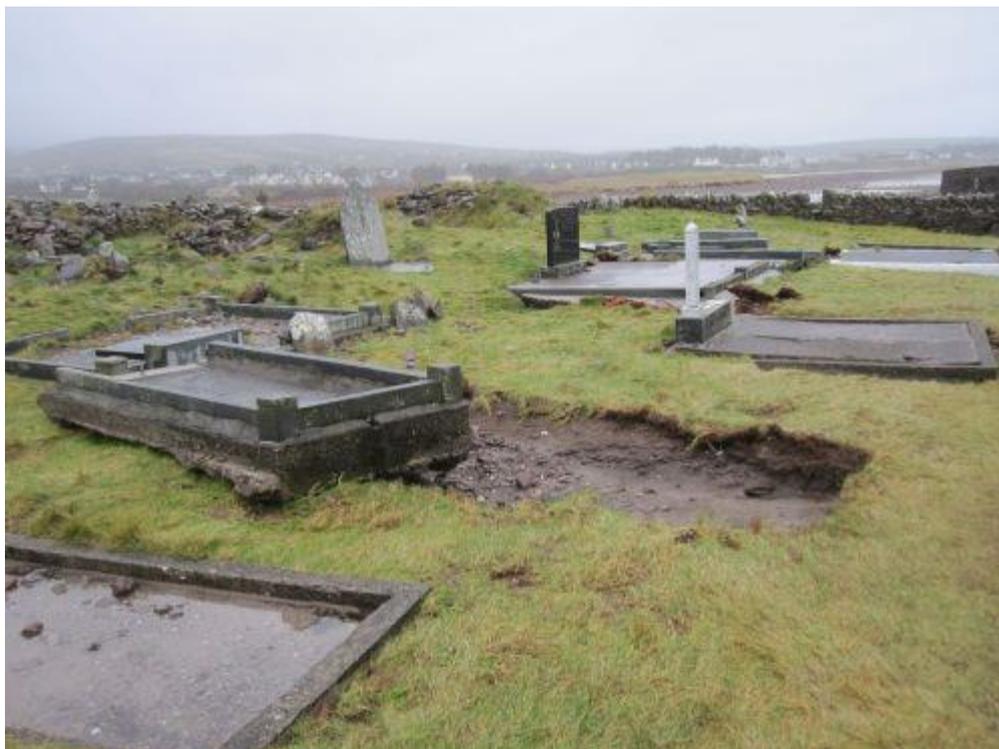
Figure 25: Storm damage in 2014 (Image credit: OPW)

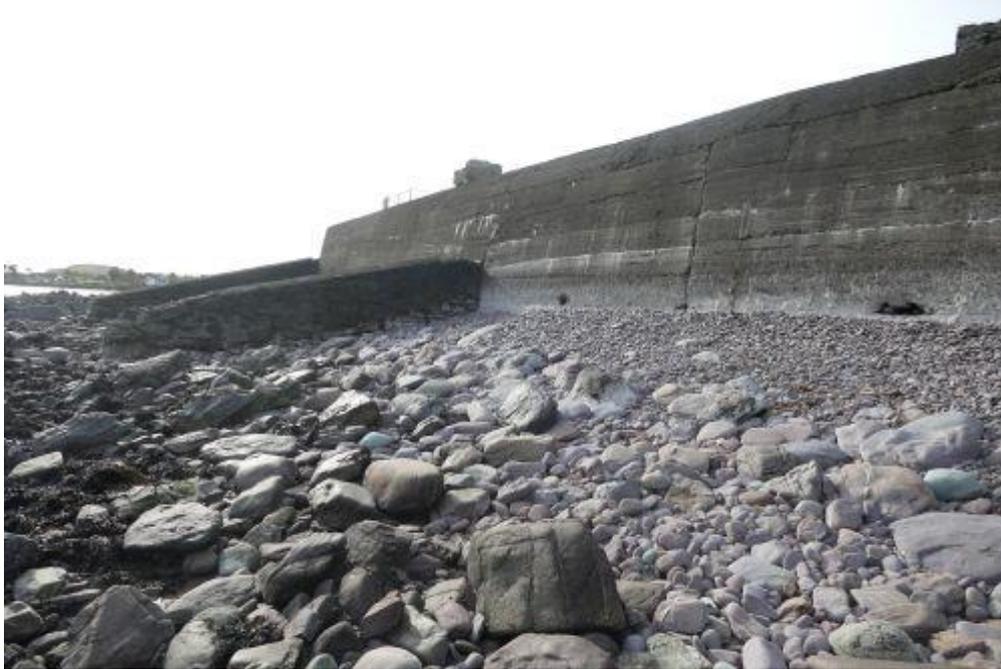
Figure 26: Erosion to existing concrete sea wall (Image credit: OPW)

The OPW has also commissioned [The Discovery Programme](#) to carry out a scan survey of the site and to monitor the coastal erosion on an annual basis (Figure 26, Figure 27). The survey data will be used to appoint a specialist consultant to advise on further coastal protection measures for the site.

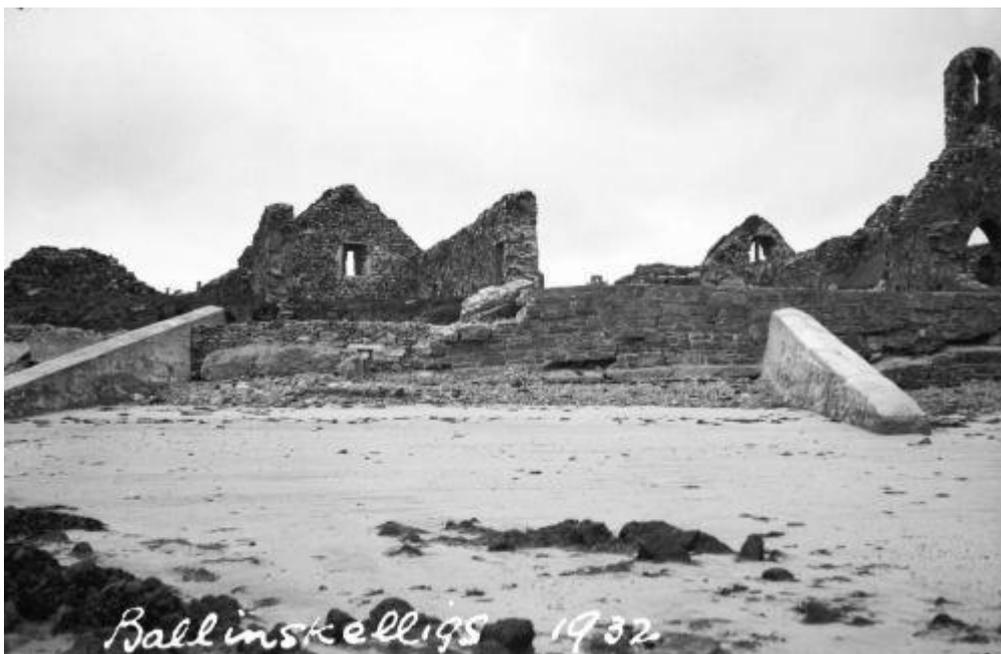
Figure 27: Archive image of the former sea wall from 1932 (Image credit: OPW)
